EVALUATION OF EPOXIES TO
PROVIDE STRESS-FREE BONDING
OF PYROCERAM MIRRORS.

PREPARED FOR
NIGHT VISION & ELECTRO-OPTICS
LABORATORY, FT. BELVOIR, VA 22060

CONTRACT No. DAAK70-77-C-0186

MAR 1979

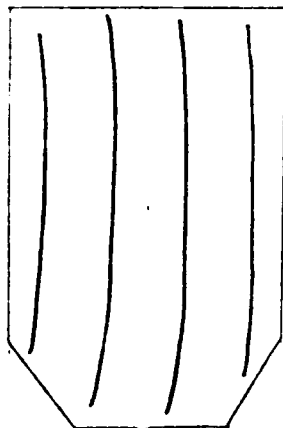
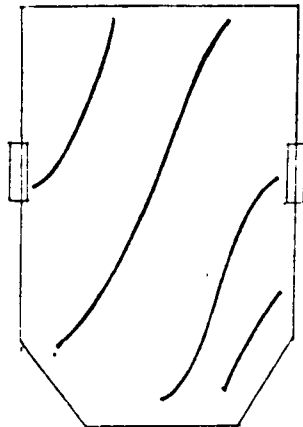
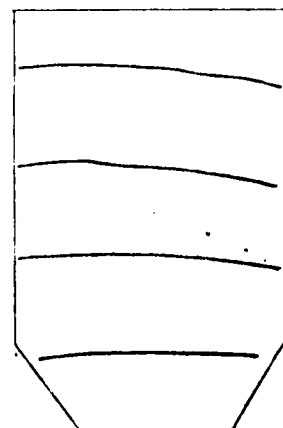
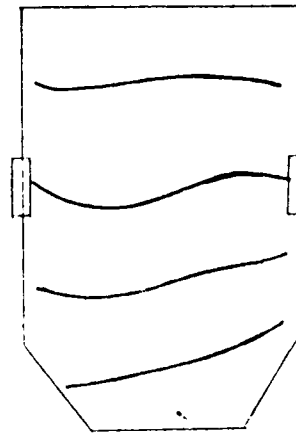
FIGURE 3. FRINGE PATTERNS, IR SIDE

Particular care was taken in this assembly to keep the arm return slot width to a minimum. In this case, the slot was made equal to that of the top cap. After the cement was cured, an interferometric measurement was made of both the IR and the visible side of the mirror. The results of these tests are shown in Figures 3 and 4. The left hand sketch shows the mirror pattern before installation of the cemented parts for both the IR and visible sides. Although a photograph of the patterns could not be made, the sketches are representative of the patterns observed. The results show that considerable improvement in the final fringe patterns can be achieved if the slot dimensions (or the cement lines) are reduced. For both sides of the mirror, the fringe patterns showed less than 3 fringes and were within specification.

a) 1 Fringe

b) < 2 Fringes

c) 1 Fringe

d) < 2 Fringes

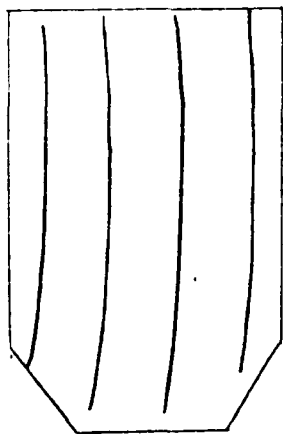
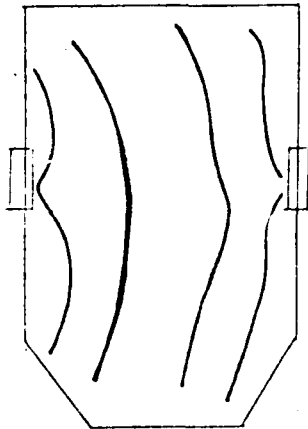
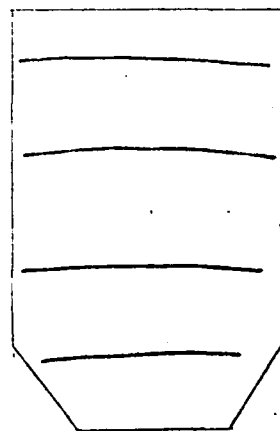
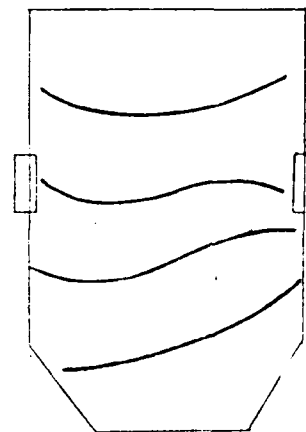
FIGURE 4. FRINGE PATTERNS, VISIBLE SIDE

a) 1 Fringe

b) > 3 Fringes

c) < 1 Fringe

d) > 3 Fringes

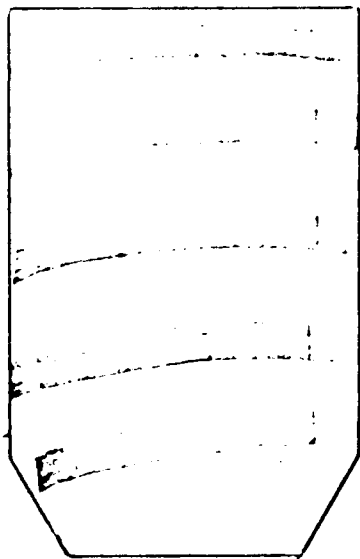
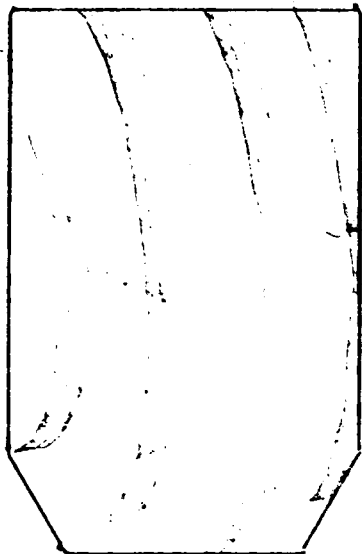
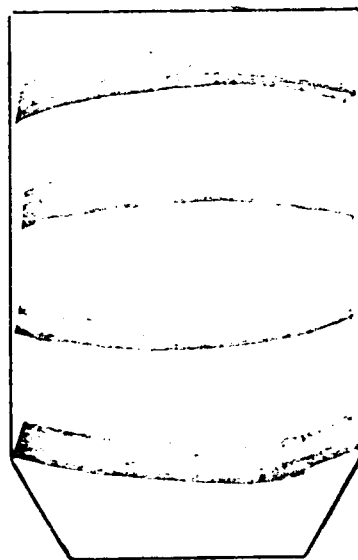
FIGURE 5. TEST MIRROR #1 FRINGE PATTERNS

IR SIDE
 $1\frac{1}{2}$ FRINGE

VISIBLE SIDE
 $1\frac{1}{2}$ FRINGE

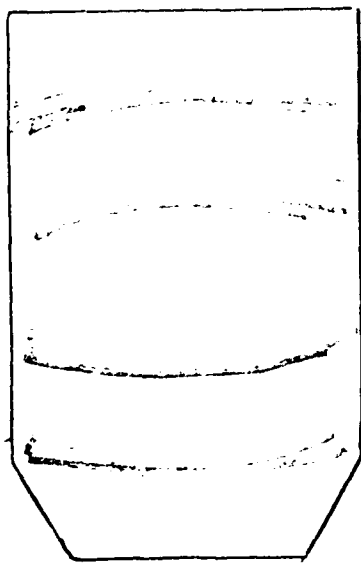
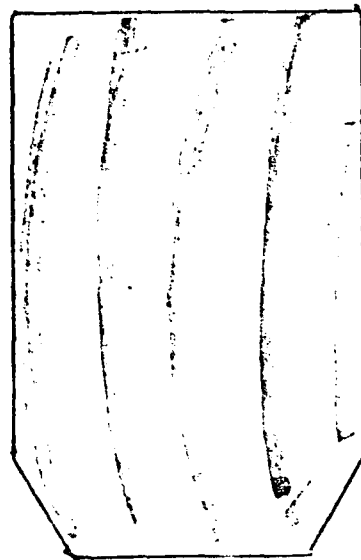
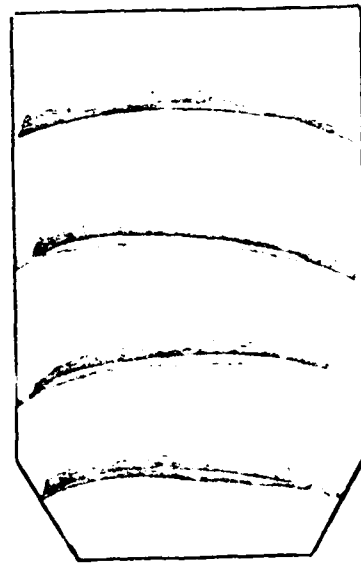
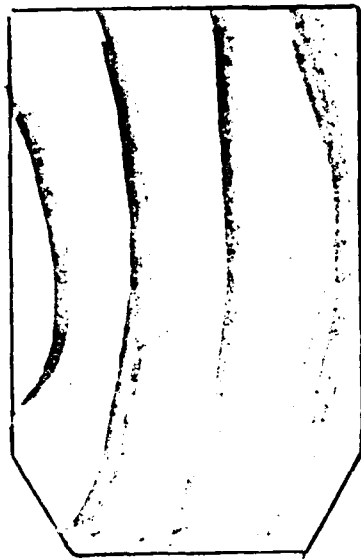
MIRROR #2, UNMOUNTED

2 FRINGE

1 FRINGE

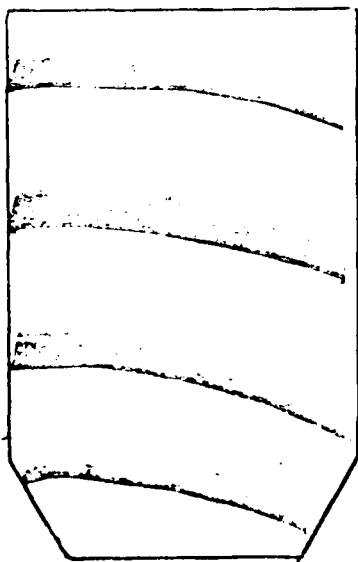
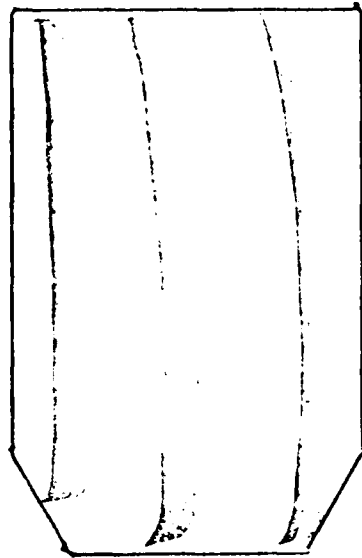
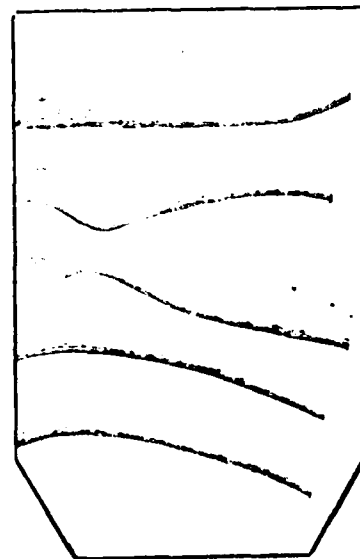
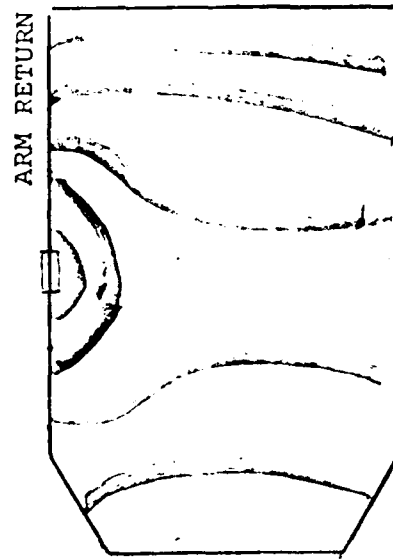
FIGURE 6.- TEST MIRROR #1 FRINGE PATTERNS

Figures 6 and 8 are sketches of the interference patterns obtained after temperature cycling. The mirrors were then tested statically at NVL using their optical test set up.

1/2 FRINGE

1 FRINGE

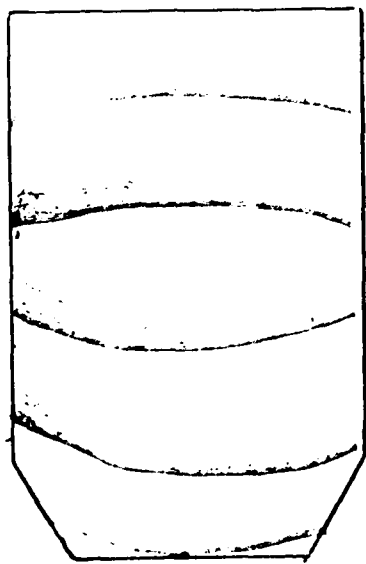
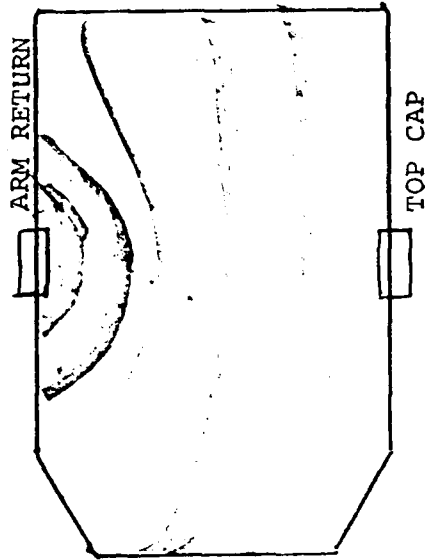
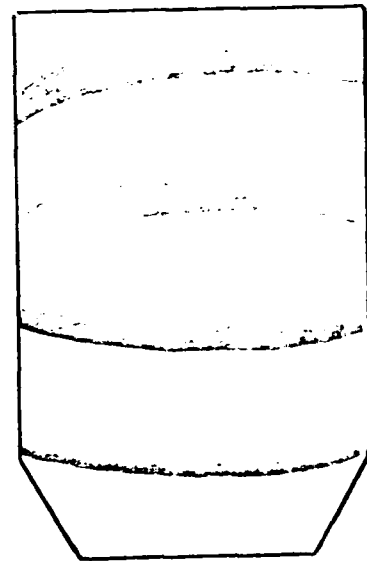
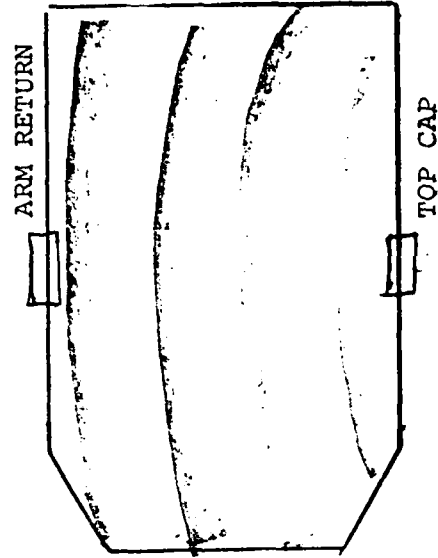
FIGURE 8.. TEST MIRROR #2 FRINGE PATTERNS

2 FRINGE

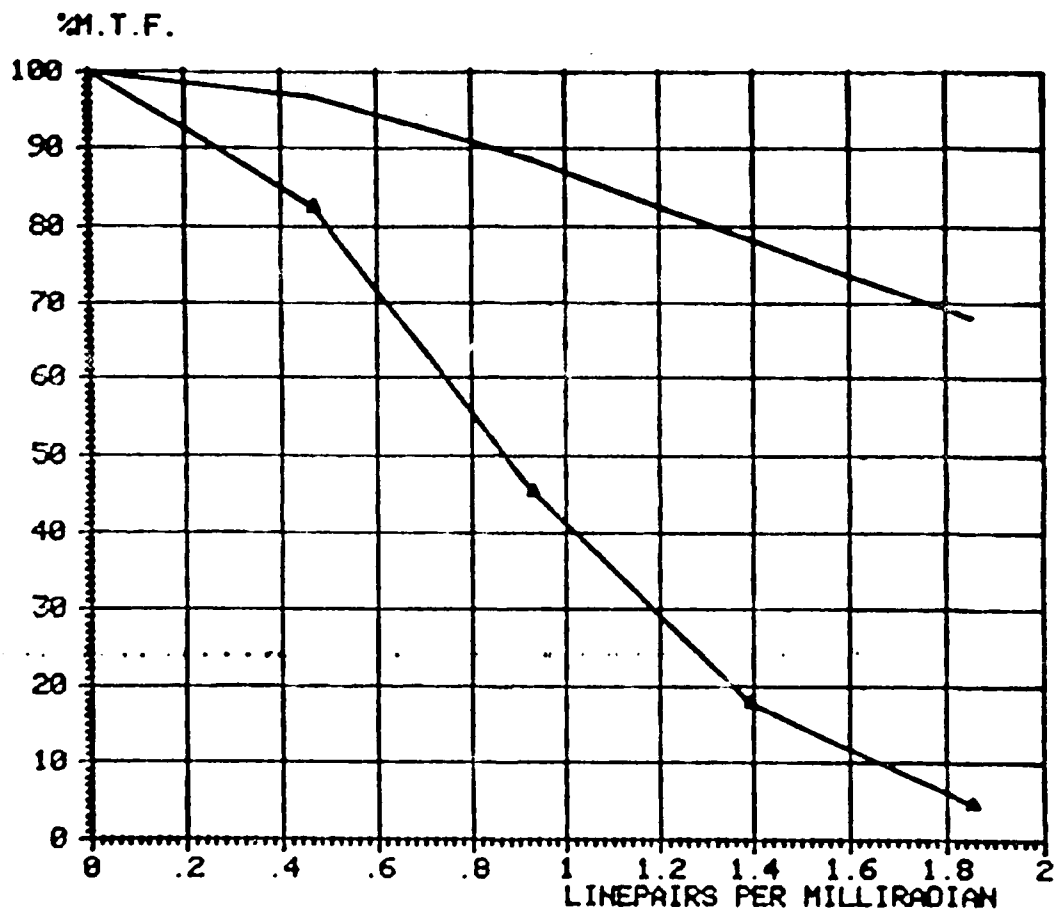
FIGURE 12

Figures 12 and 13 are the printouts of the static MTF curves achieved. In these curves, the azimuth pattern still meets the required MTF limits. However, the elevation pattern shows that there is considerable vertical astigmatism in this mirror. Based on the curves shown in Figures 5-8 for a typical mirror, it was assumed that this astigmatism is a result of assembly.

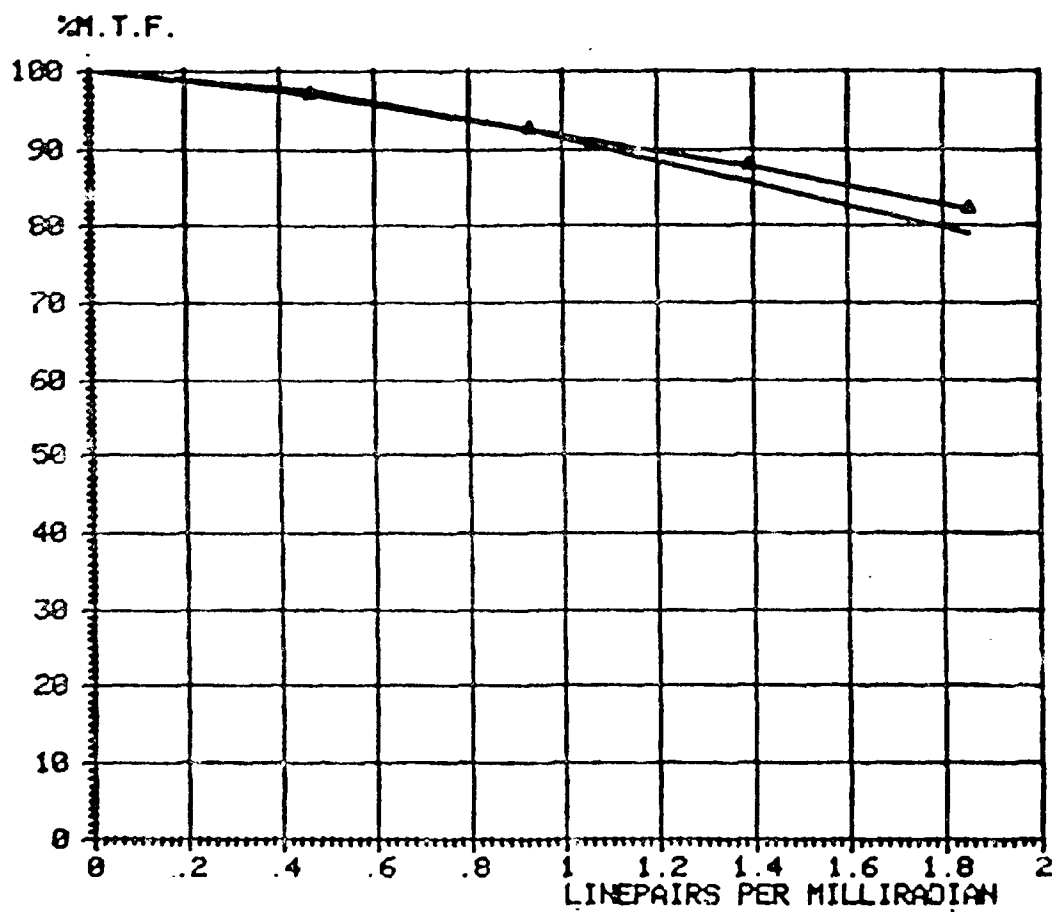
FIGURE 17

Figures 17 and 18 show equally good results on Mirror #002 for the same static test.

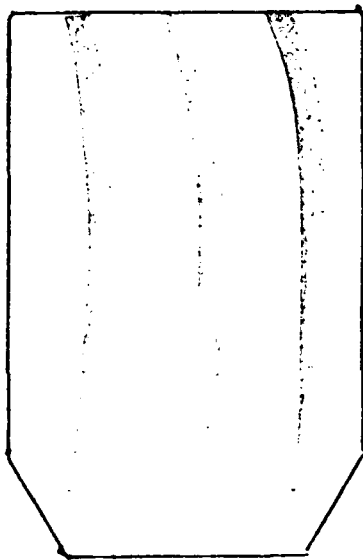
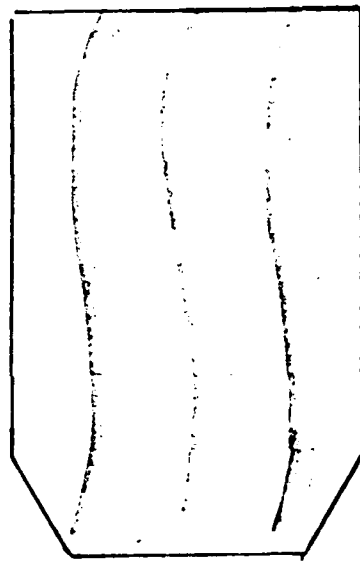
FIGURE 19 FRINGE PATTERN S/N 003

Mirror assembly #003 was then subjected to a high temperature (400°F) cycle for 10-15 minutes to break the epoxy cement bond. After removal of the top cap and arm return, the mirror was rechecked for flatness and distortion. Figure 19 is a sketch showing the fringe patterns which resulted. The significance of this test is the fact that the mirror can be restored to its original state and therefore those mirrors which do not pass MTF checks can, at least, be salvaged and re-assembled. The cost of rework would therefore not involve a completely new mirror. It should be noted however that the mirror may require repolishing and recoating.

I R SIDE, 1/2 FRINGE

VISIBLE, 1/2 FRINGE

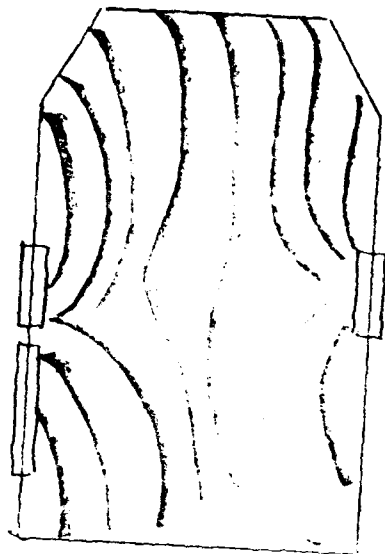
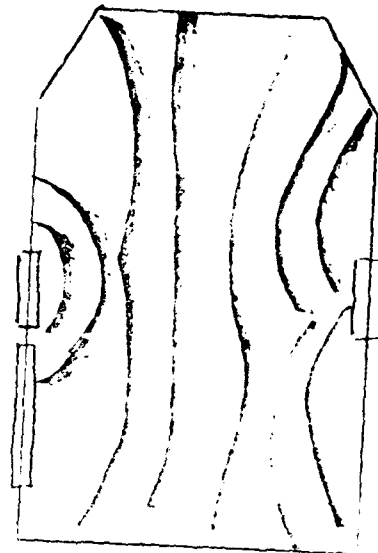
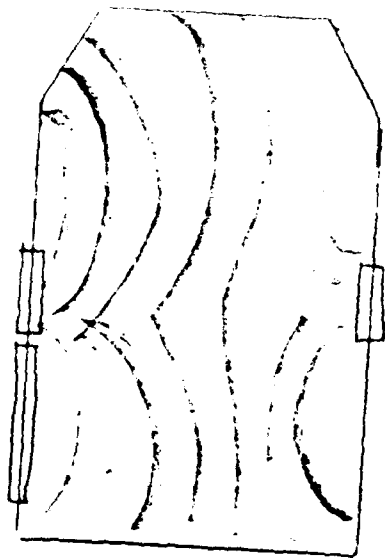
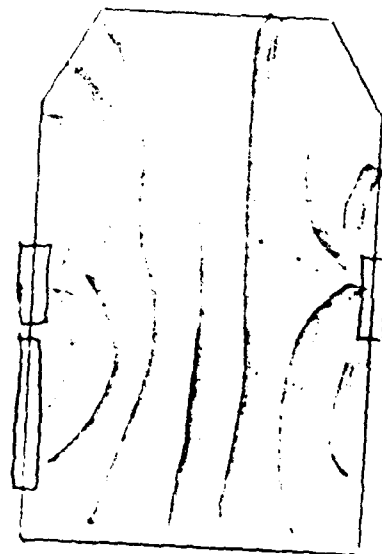
FIGURE 20 FRINGE PATTERNS S/N 004

Serial #004 was then assembled and tested after cycling through the initial and final cementing processes. In this case, there was a small improvement in the distortion over that of #003. However, the patterns show approximately 4 fringes with an irregular pattern. (See Figure 20.)

10/13/78 VISIBLE
4 FRINGE IRREG.

10/19/78 VISIBLE
2-3 FRINGE IRREG.

10/13/78 IR
4 FRINGE IRREG.

10/19/78 IR
2 FRINGE IRREG.

Mirror #004 was rechecked after six days at room temperature. Figure 20 shows that some additional stress relief had occurred in this period. The reason for this could not be determined.

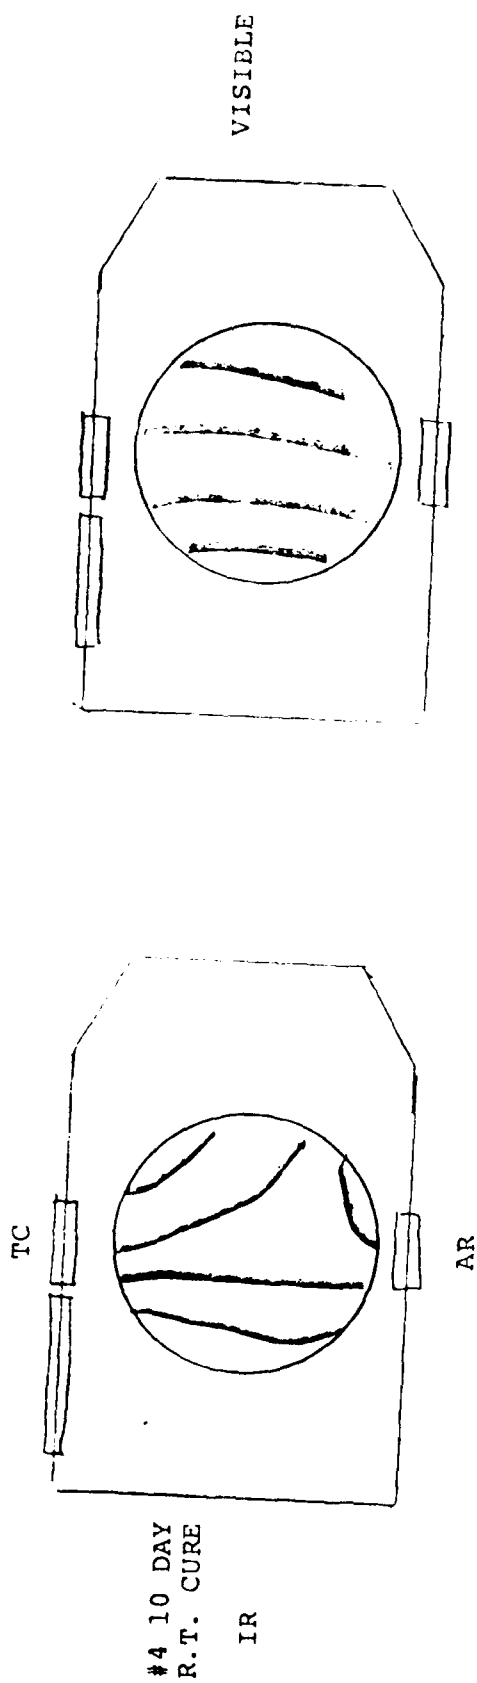
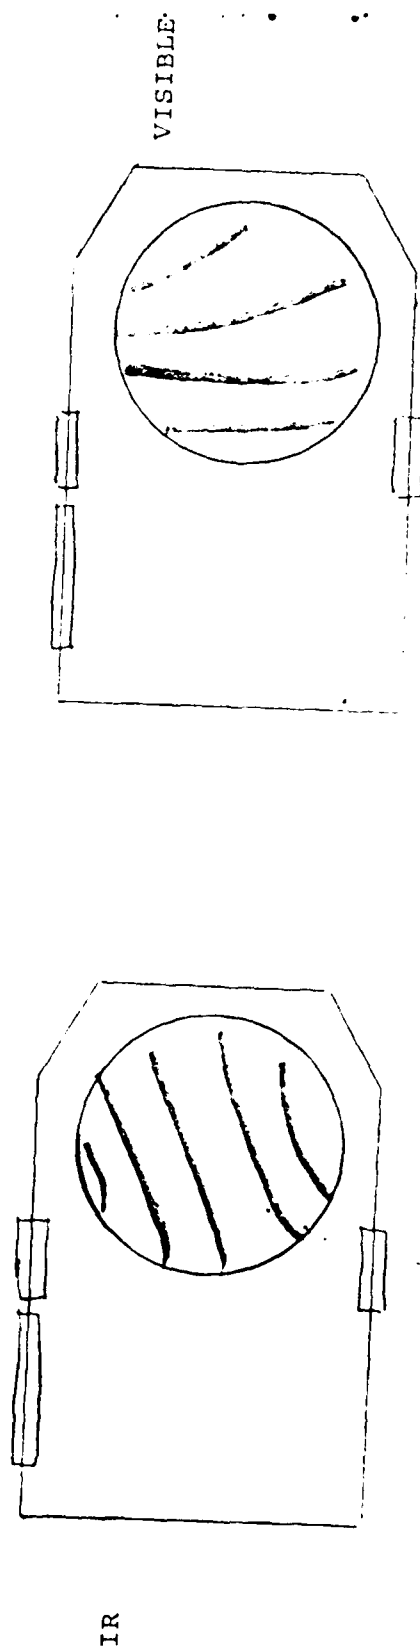
FIGURE 21. FRINGE PATTERNS S/N 004
10 DAY ROOM TEMP AFTER CURE CYCLE

Since there was an obvious change in Mirror #004 stress pattern, a further check was made using an optical flat survey. Figure 21 is a representative sketch of this pattern. The optical flat survey shows some further change but it is difficult to estimate the number of fringes. It was estimated that Mirror #004 showed a fringe response which exceeded the mirror specification.

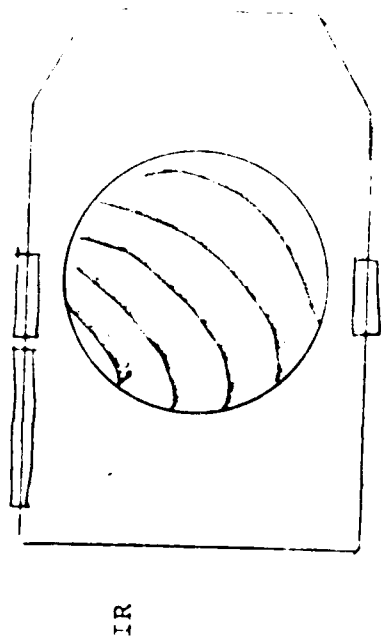
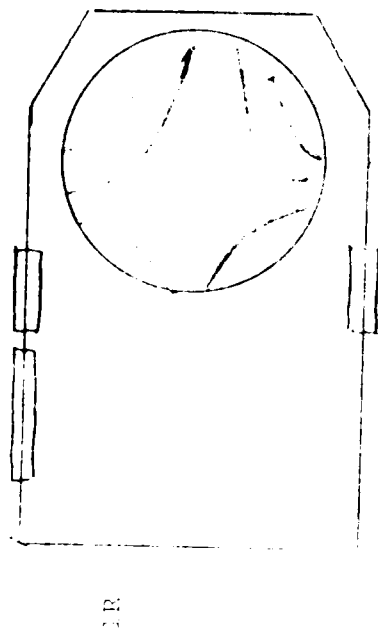
FIGURE 22. FRINGE PATTERNS S/N 005 AFTER FIRST FULL CYCLE
24 HOURS AT ROOM TEMP.

For Mirror #005, the fringe pattern was taken (optical flat survey) after the first room temperature curing cycle. Figure 22 shows a representative pattern.

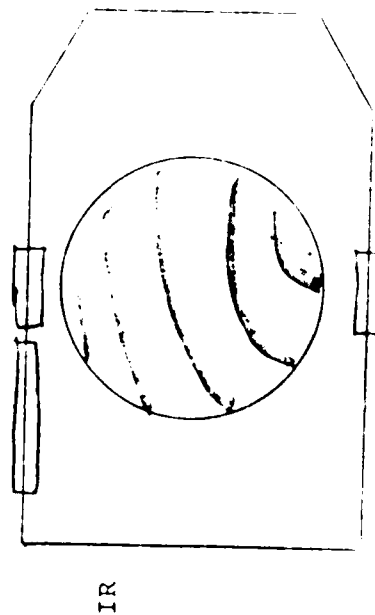
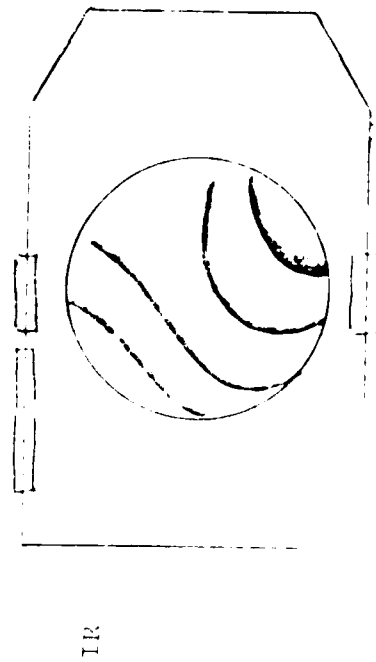
FIGURE 23. FRINGE PATTERNS S/N 009
AFTER FIRST FULL CYCLE NOT STRESS RELIEVED

On Mirror #005, the temperature cycle recommended by NVL was interrupted after the polymerization cycle and an optical flat survey was made of both sides. There was an indication of stress caused by the cement on both the top cap and the arm return. This stress showed in an irregular pattern of about 3 fringes. (Figure 23.)

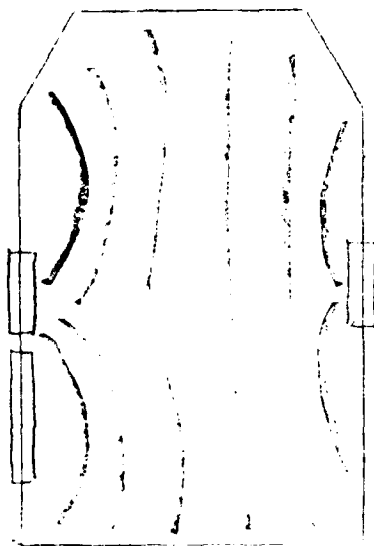
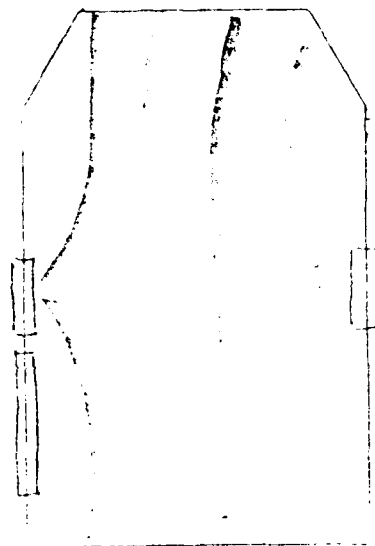
FIGURE 24. FRINGE PATTERNS S/N 005
AFTER FULL CURE CYCLE

The temperature cycling was then completed by going through the low temperature (-62°C) and then high ($+95^{\circ}\text{C}$) for four hours at each temperature. Upon completion of this cycle the mirror was surveyed using an optical flat and a definite improvement in the number of fringes was observed (see Figure #24). However, there is still a basic irregularity to the mirror surface near the metal parts with a more regular area towards the center of the mirror. On this basis, the mirror was tested for MTF in order to establish a correlation between fringe patterns and MTF response. As shown in later tests, this correlation has not been found.

2-3 CYLINDRICAL

1-2 FRINGE IRREG.
3 ARM RETURN

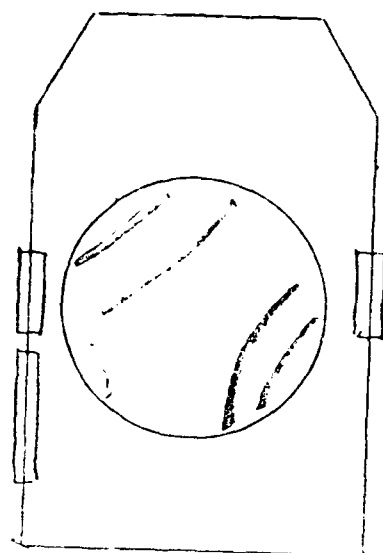
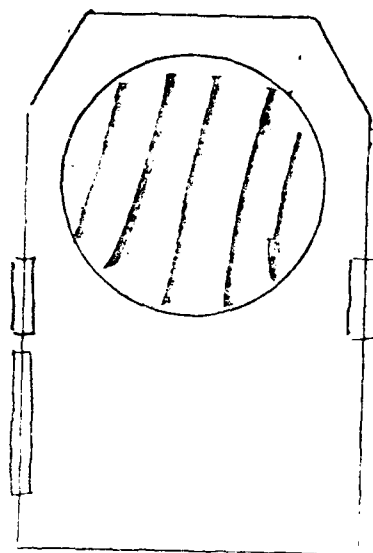
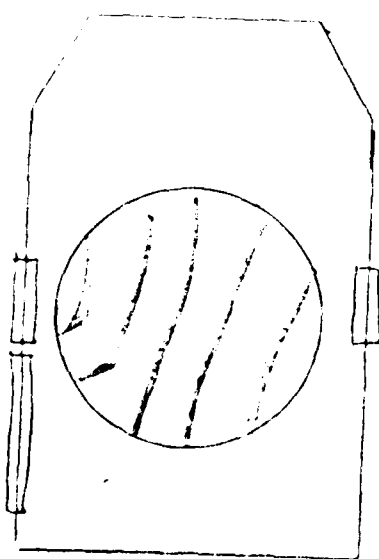
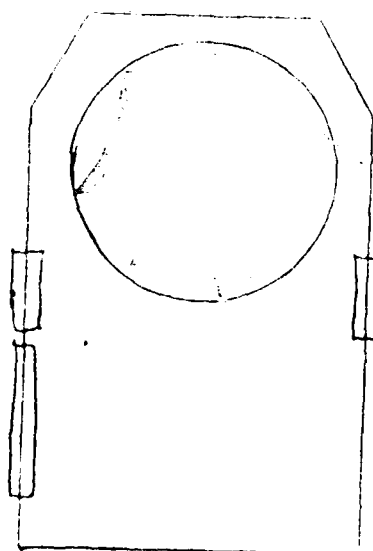
FIGURE 25. FRINGE PATTERNS S/N 005
4 DAY ROOM TEMP AFTER CURE CYCLE

For Mirror assembly #005, a recheck (Figure 25) was also made using an optical flat survey once more. There are changes to these patterns but an overall fringe response could not be estimated.

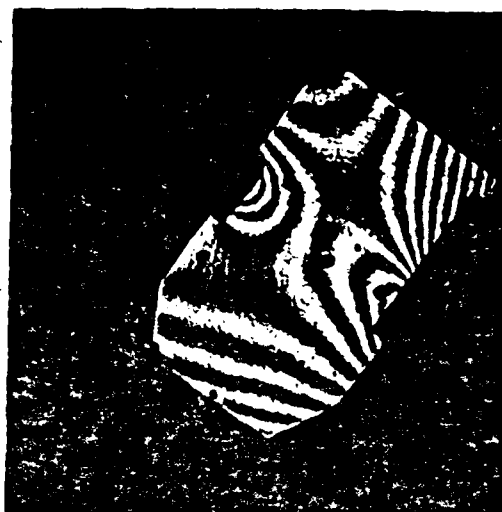
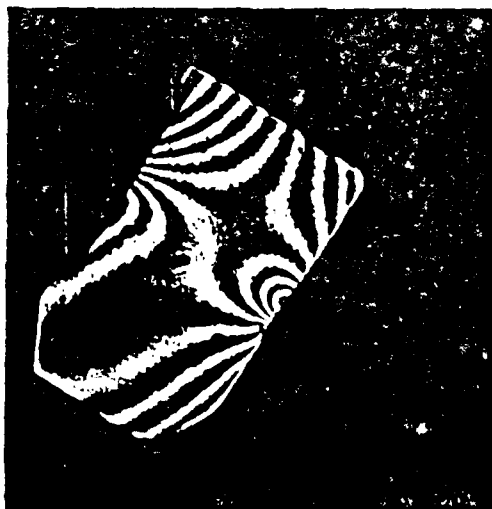
FIGURE 26. INTERFEROGRAMS, S/N 004

MTF tests were then run on Serial #004 and #005 mirror assemblies. Figure 16 is a reproduction of interferograms of Mirror #004 and reflects the fringe patterns measured by optical flat survey. Both the IR side and the Visible side show 2-3 fringe characteristics with irregularities. The significant part of these interferograms is that the stress patterns show that the top cap introduced considerably greater stress than the arm return. This distortion in the mirror shows that in Mirror #004 there is an overall azimuthal distortion affecting the MTF in that direction. The MTF was then run on both the Visible and IR sides (see Figures 27 thru 30) to determine what MTF a pattern of this nature would yield. Figure 17 shows that the MTF of Serial #004 on the IR side has an elevation MTF which more than exceeds the required MTF. However, the azimuthal pattern shows that it just misses the required value. In view of this, a second run was taken on the same side of the mirror in which the focus was readjusted. The same basic pattern shows up in the MTF printout (Figure 18) with the elevation exceeding spec and azimuthal just missing.

A similar set of MTF runs was taken on the Visible side (Figures 29, 30) using the same procedure. Figure 26 shows the interferogram of the Visible side of the same mirror. The patterns are essentially the same as that shown for the IR side and the astigmatism in the azimuthal plane is also reflected in the MTF response. Once again the focus was readjusted and a change from the original pattern occurred. In this case, azimuthal MTF dropped from 94% to 93%. The test was then re-run adjusting the focus one more time and the elevation MTF was now affected as well.

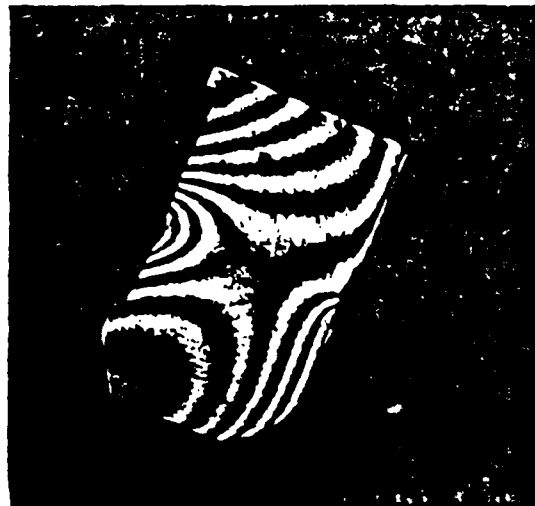
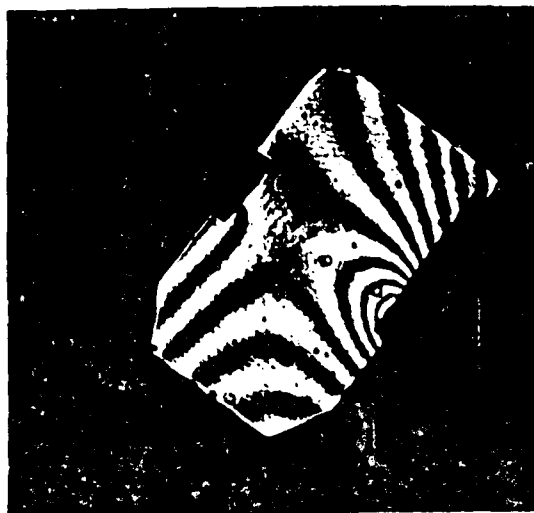
FIGURE 31. INTERFEROGRAMS, S/N 005

Mirror #005 was also subjected to the same sequence of testing. The interferograms shown in Figure 31 show a slight reduction in the distortion patterns after the full cure cycle. Specific changes were made to the assembly procedure for Serial #005. A 4.1% hardness by weight was used

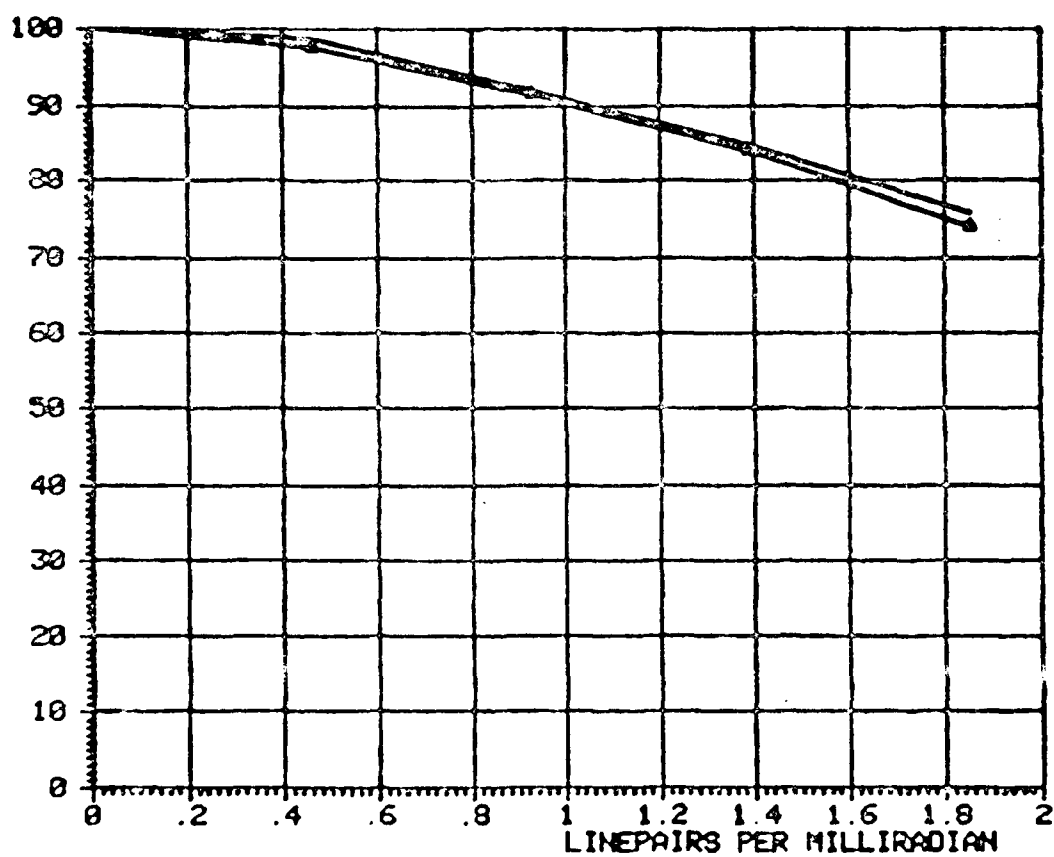
FIGURE 32. MTF RESPONSE, S/N 005, I R SIDE

and every possible source of stress in the mirror assembly was eliminated before final cementing. Figure 32 shows the MTF response of the IR side of the mirror and indicates that for both elevation and azimuthal axis the mirror has passed the MTF requirement.

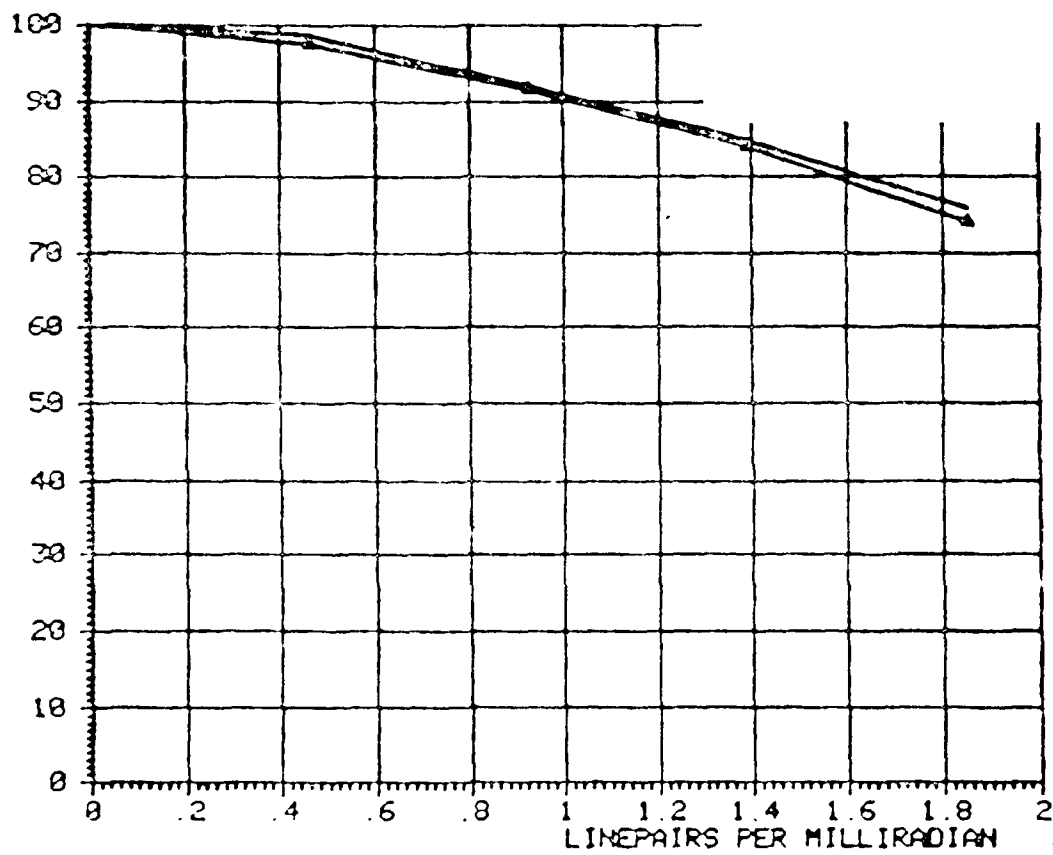
FIGURE 33. MTF RESPONSE, S/N 005, I R SIDE

More significantly, this characteristic was obtained after a number of refocusing trials were made. Figure 33 shows the net result of these retrials as the focus was readjusted. The Visible side characteristics shown in Figures 34 and 35 also indicated essentially the same characteristics as described for the IR side.

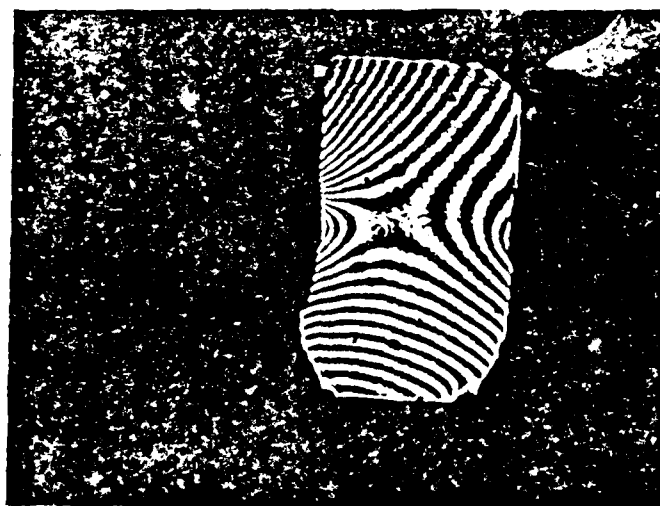
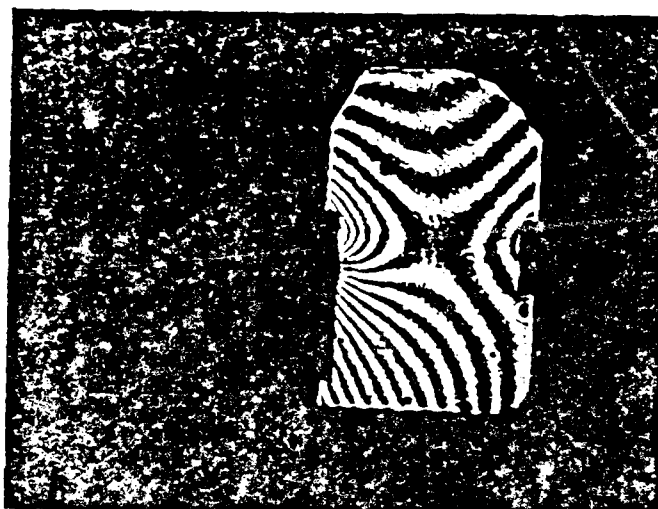
FIGURE 36. INTERFEROGRAMS, S/N 006

Mirror #006 assembly was also tested for MTF response. In this case, the final epoxy gap was kept to a nominal .002" and the entire assembly was subjected to the cure cycle described previously. Figure 36 is an interferogram taken for both IR and Visible sides. These interferograms

show that considerable distortion had occurred on both the top cap and arm return sides of the mirror with a net effect of a saddle occurring on what was originally a $1/4$ to $1/2$ fringe regular mirror. Of interest in these two patterns is the fact that the arm return showed considerably more stress than the top cap side. Examination of the interferograms yields approximately a 3-fringe irregular surface for the IR side and similarly a 3-fringe irregular surface for the Visible side. The MTF test was run on this mirror, which is obviously poor, for the sake of completeness and Figure 37 shows the resultant MTF response obtained. From this, it can be seen that the saddle effect results in astigmatic characteristics which yield no more than about 75% MTF in the azimuthal plane and considerably better, but below specification, in the elevation plane.

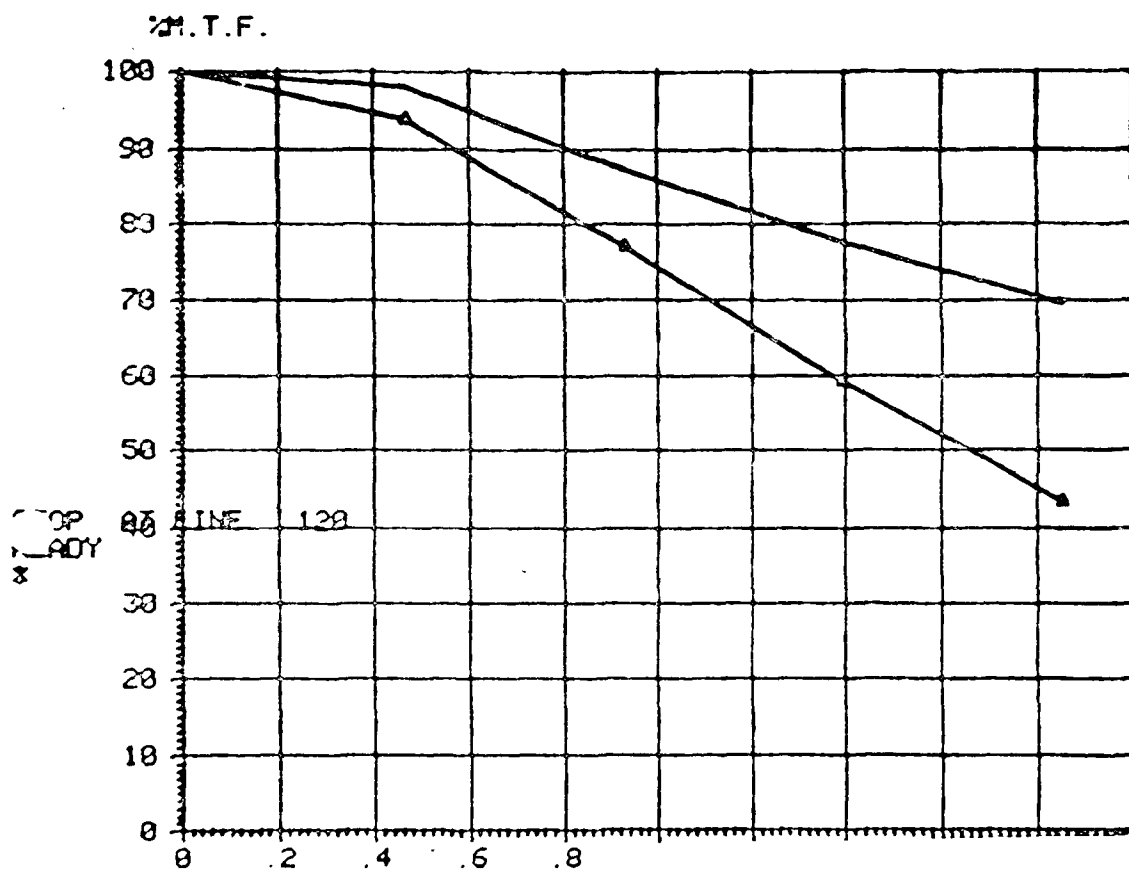
FIGURE 38. MTF RESPONSE, S/N 006, VISIBLE SIDE

The MTF equipment was refocused to see if a more optimum focal point could be achieved. In this case, the azimuthal and elevation planes reversed themselves with similar patterns. The MTF was then taken on the Visible side (Figure 38) and although the surface showed astigmatism, the elevation plane again failed to meet the requirement by a considerable margin and the azimuthal plane also fell below requirements. The test equipment was refocused again with the response shown in Figure 39 resulting.

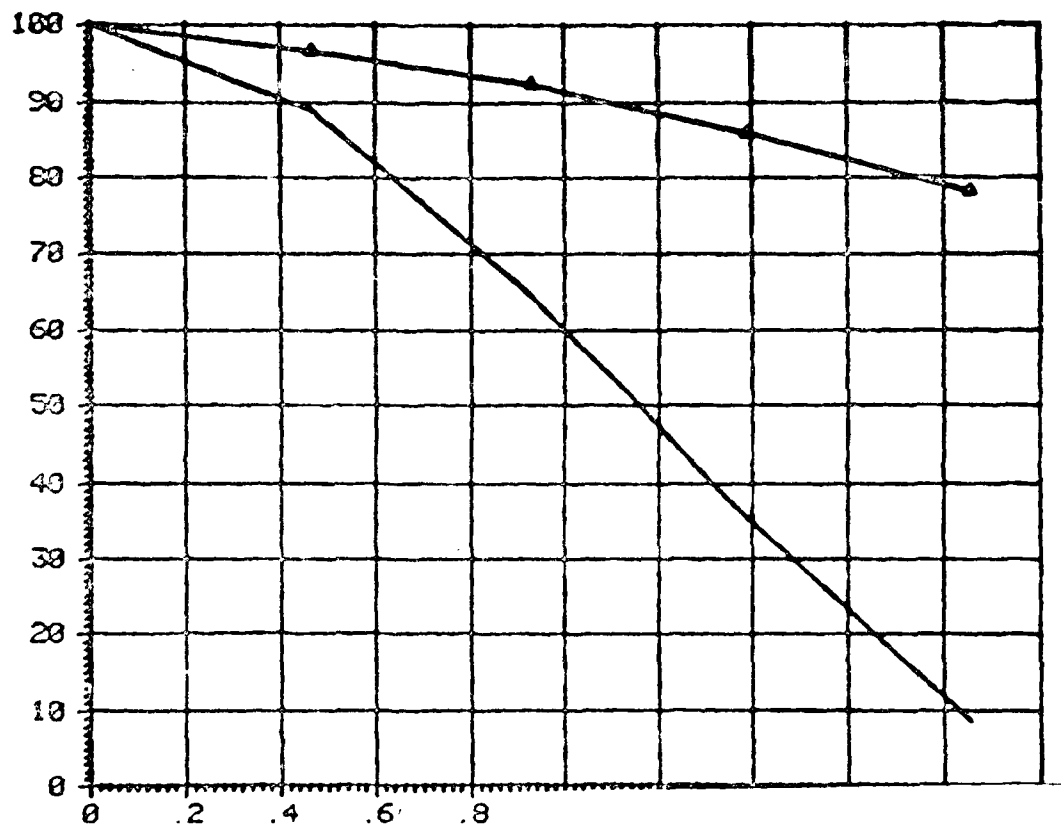
FIGURE 39. MTF RESPONSE, S/N 006, VISIBLE SIDE

At this point, the test on Serial #006 was stopped since it was obvious that no matter what focal point was chosen, the mirror was just not going to make it. As it turned out, Mirror #006 proved to be of great value in the study in that the cause of such a poor response was then carefully investigated and the results of this investigation led to changes in the fixture and approach to the assembly.

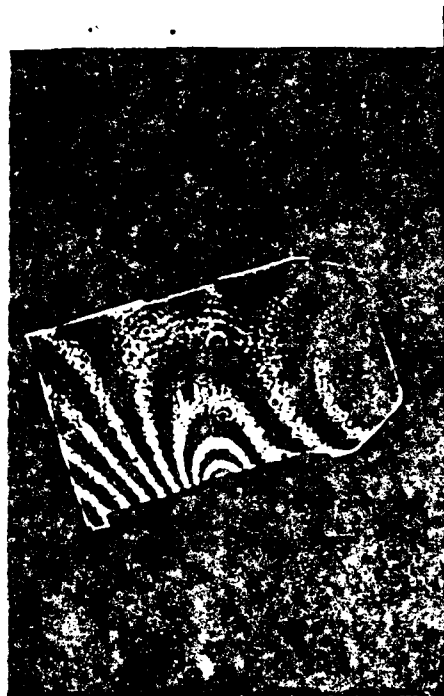
FIGURE 42. INTERFEROGRAM, S/N 007, VISIBLE SIDE

Figure 42 is an interferogram of the Visual side of the mirror and shows that there are stress lines evident at the arm return/mirror assembly point. This should be highlighted since in previous assemblies the top cap button has shown similar stress concentrations and yet this mirror shows almost zero stress at the top cap button. This serves to highlight the randomness of the stress imposed by the cement (2 part epoxy 4.1%) to both parts. In this case, the final gap was set at .002" for both the top cap and arm return parts on each side of the mirror.

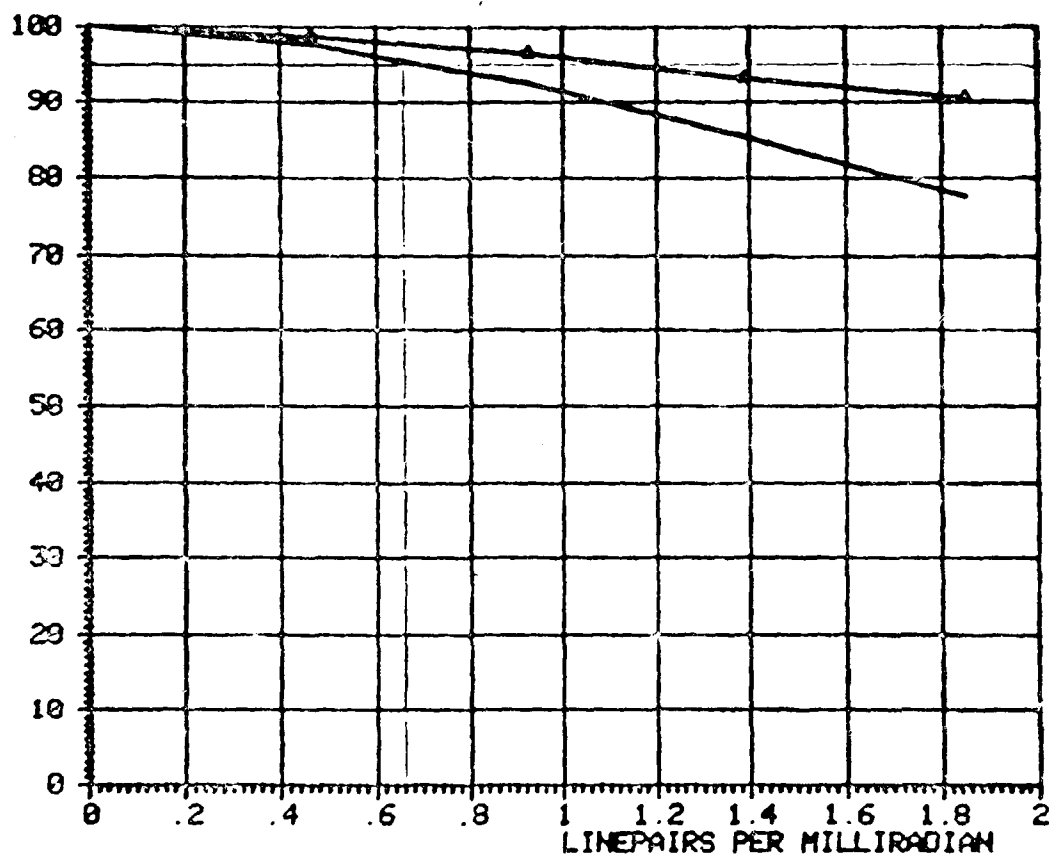
FIGURE 44. MTF RESPONSE, S/N 007, I R SIDE

A plot of the MTF achieved for the IR side is shown in Figure 43. In this case, the mirror passes the MTF requirements with an indication of some astigmatism in the azimuthal plane. The focus was readjusted from the point at which the first MTF was taken and Figure 44 is a plot of the second MTF achieved. In this case, the astigmatism is more clearly defined with the mirror achieving the required MTF azimuthally but shows that adjustment of the focal point between sagittal and tangential focus improved the elevation pattern. For the

purposes of completeness, this test was rerun by moving the focal point one more time with the same basic pattern resulting. The conclusion drawn from these results was that, depending upon the effective astigmatism in the mounted mirror and the focal point chosen, a rather significant variation in the MTF response (for both planes) can be arrived at. It is a moot point to describe whether the amount of astigmatism shown on the IR side can be calibrated against the interferometric pattern shown in Figure 41.

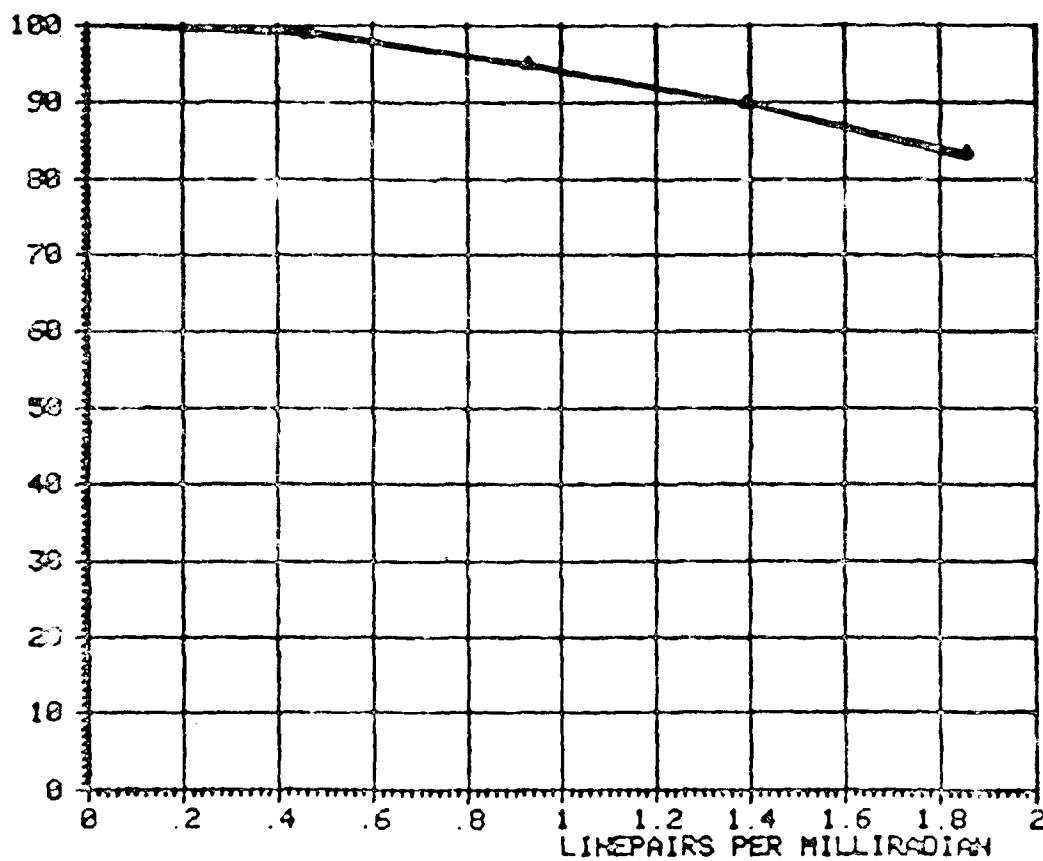
FIGURE 45, MTF RESPONSE , S/N 007, VISIBLE SIDE

Figure 45 is a plot of the MTF achieved for the Visible side and shows that the specification has been met in spite of arm return distortion shown in Figure 42. Interestingly enough, the amount of astigmatism produced by this side of the mirror is effectively nil and the azimuthal and elevation patterns are essentially congruent and that in spite of the stress patterns evident along the arm return side, the MTF is excellent.

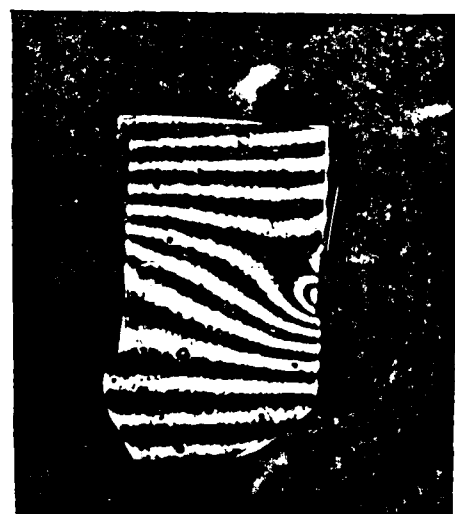
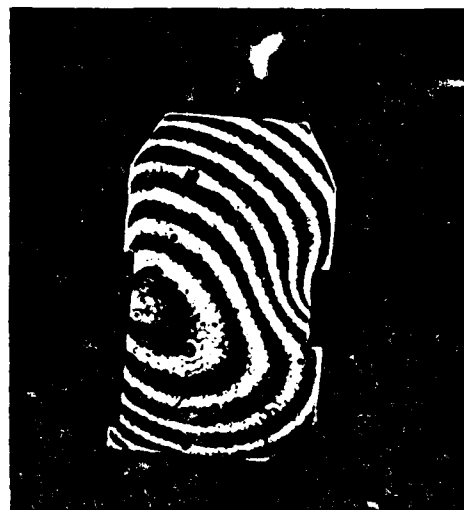
FIGURE 47. INTERFEROGRAMS, S/N 008

exhibited by both sides of the mirror. This unit was then subjected to the NVL temperature cycle and over the central portion showed a considerable shift from the previous pattern exhibited before temperature cycling (Figure 47). In this case, the top cap still showed distortion patterns which were greater than that shown on the arm return side. A rough estimate of the number of fringes using an optical flat surface showed approximately 2 fringes or more with some irregularity being evidenced on both sides.
